REPORT NO. 2000036.401
REVISION: 0
PROJECT NO. 2000036.00
November 2020

Examination and Analysis of Equipment Involved in Mr. Justin Moore's June 8, 2017, Fall Incident

United States District Court
Northern District of Texas
San Angelo Division

Justin Moore and Judith Moore vs DB Industries, LLC, et al.

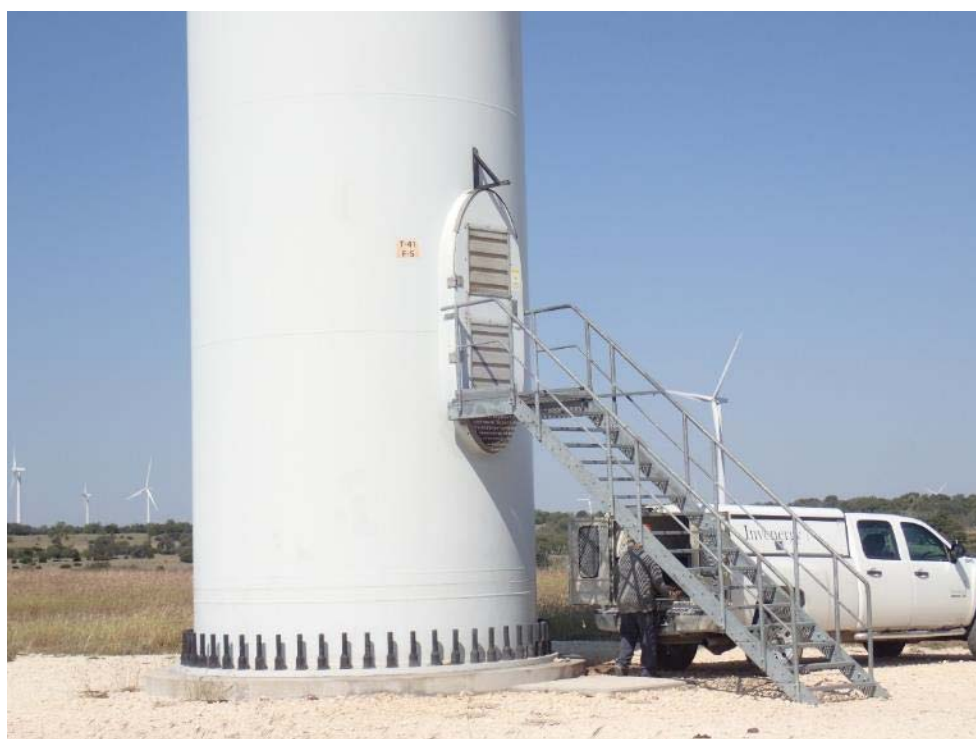
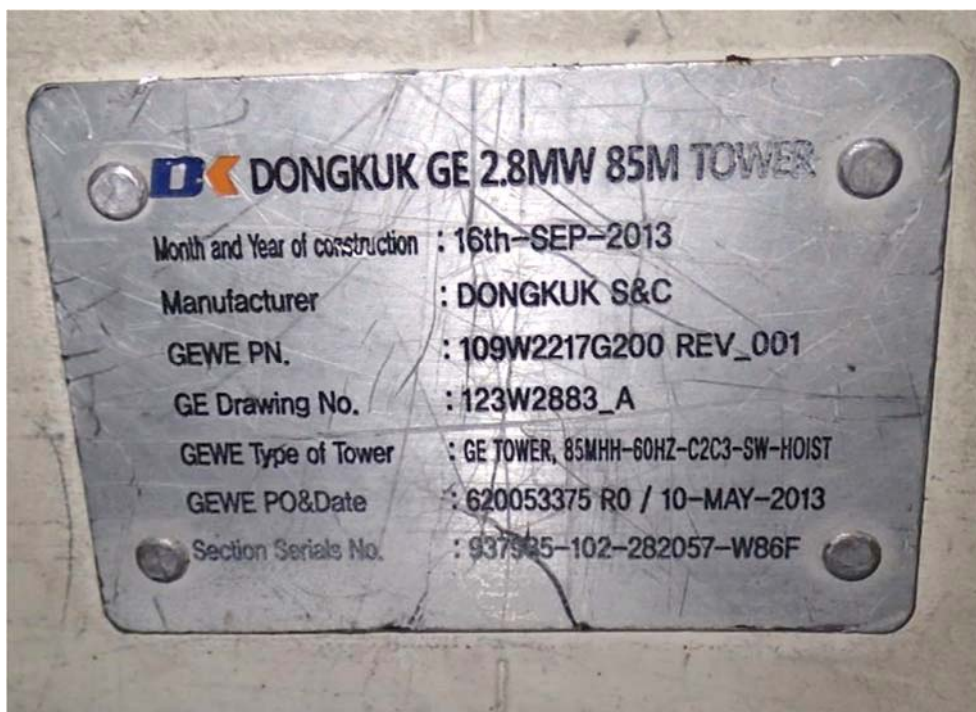
Tower 41 at the Invenergy wind farm facility near Goldthwaite, Texas, was visually examined on October 6, 2020. As described in Section 1, the tower access door is located at the top of an external stairwell (Figure 1). Once inside, a fixed vertical ladder, approximately 20 feet in height, is used to access the base deck. The top of this ladder ends a few feet above the base deck elevation, and from the base deck a separate fixed vertical ladder extends to the middle deck, the saddle deck, and the yaw deck (Figures 2 and 3). The ladder used to access the base deck is equipped with a Tuf-Tug cable for attaching cable sleeves when climbing, but is not equipped with a climb assist system (Figure 3, lower image).

Figure 1. View of the base of Tower 41 at the Invenergy wind farm near Goldthwaite, Texas (upper image) and close view of a manufacturer's label on the inside wall near the base deck (lower image).

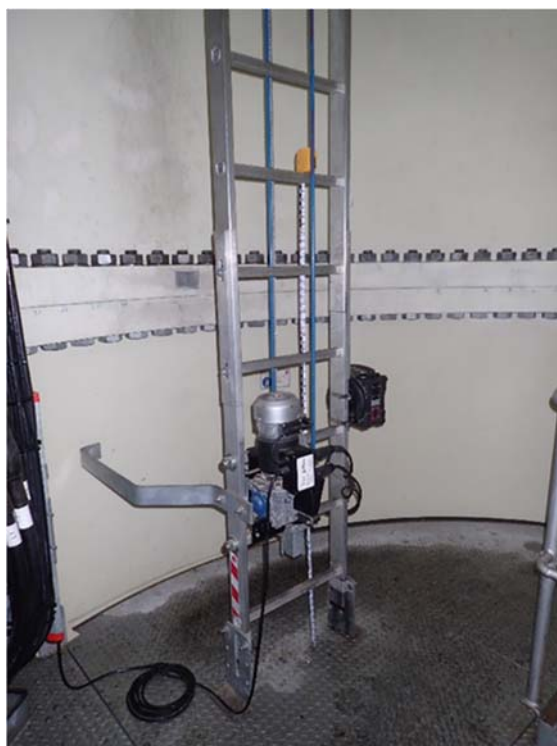
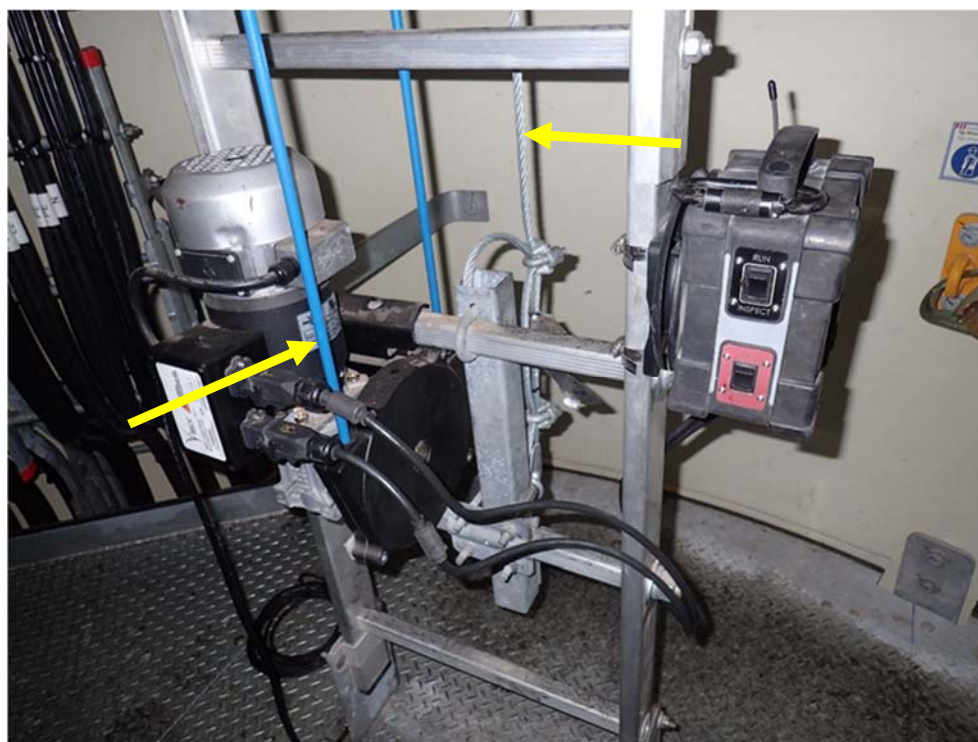
Figure 2. Views of the bottom of the vertical, fixed ladder at the base deck of Tower 41. In the lower image, the left arrow indicates the location of the IBEX climb assist belt, and the right arrow indicates the location of the Tuf-Tug cable that the climbers' sleeves attach to.

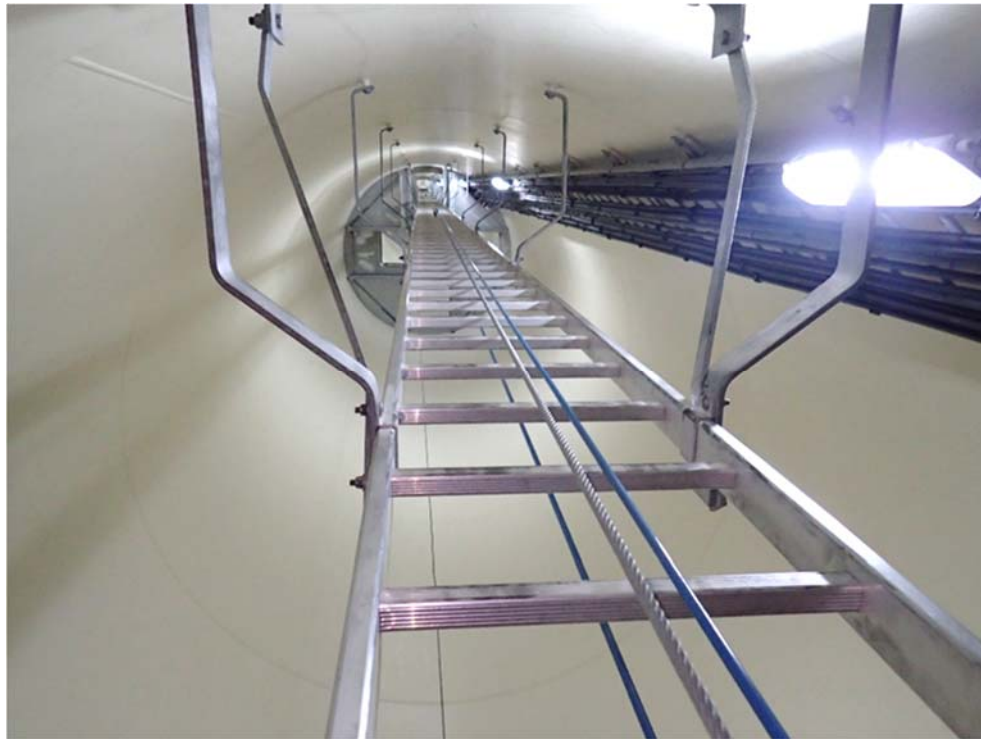
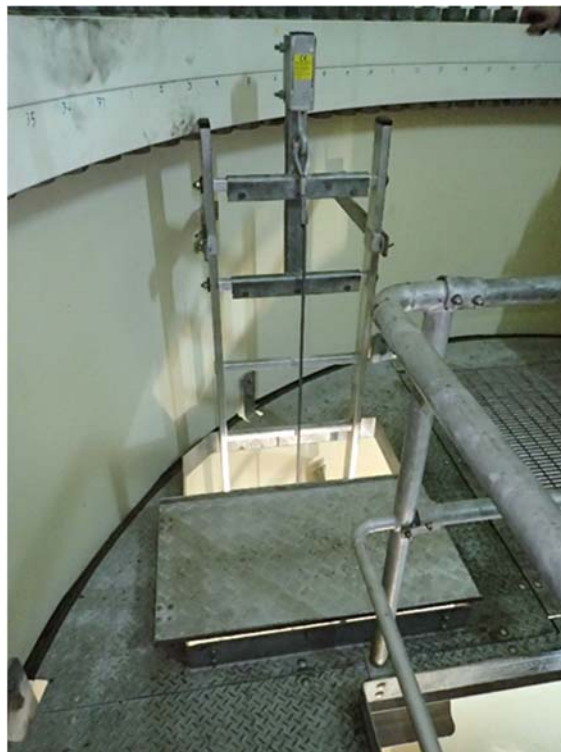
The ladder that is used to climb from the base deck to the yaw deck is equipped with an IBEX climb assist system and a Tuf-Tug cable; the IBEX polymer belt and the Tuf-Tug steel cable are routed side-by-side near the middle of the ladder (Figure 3, upper image). The IBEX system has a motorized drive unit that is attached to the bottom of the ladder, and a portable control unit that attaches to the side of the base of the ladder (Figure 2). The Tuf-Tug cable is also attached to the bottom rungs of the ladder. The IBEX belt consists of a full loop that passes through the drive unit at the bottom and around a pulley located at the top of the ladder; operation of the system produces a load on the belt that lifts up on the pendant (attached to the climber), regardless of whether the climber is ascending or descending.

Figure 3. Views of the tower ladder looking up from the base deck (upper image) and the top of the base deck access ladder (lower image). In the upper image, the IBEX belt and Tuf-Tug cable are visible at the middle of the ladder. In the lower image, the hatch door is closed, and only a Tuf-Tug cable is present (this ladder, which is approximately 20 feet in height, is not equipped with a climb assist system).

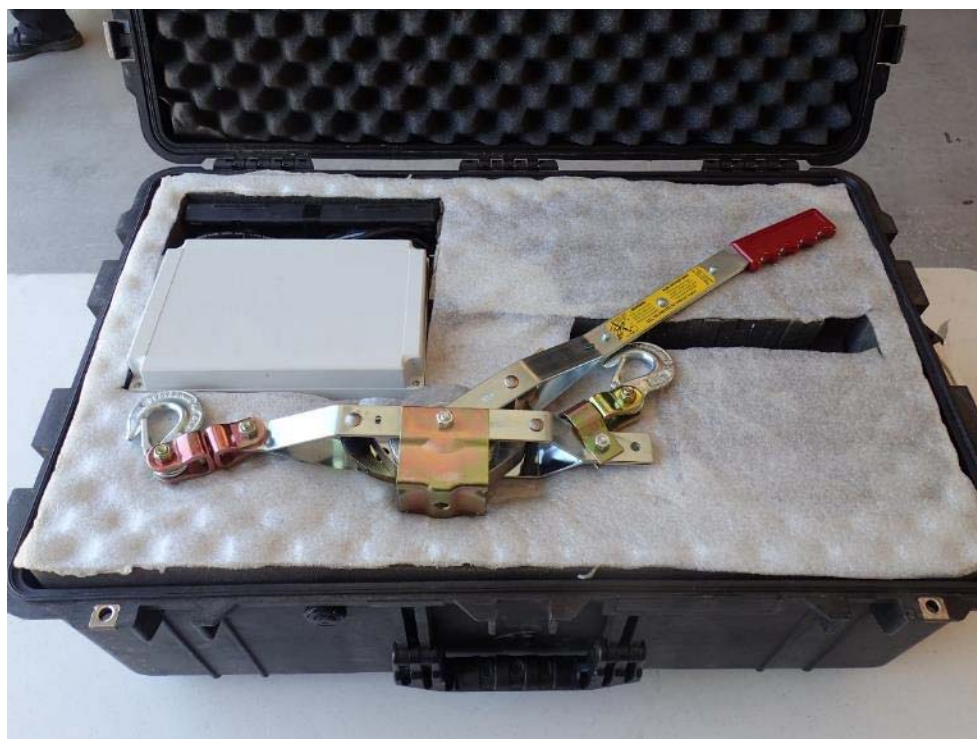
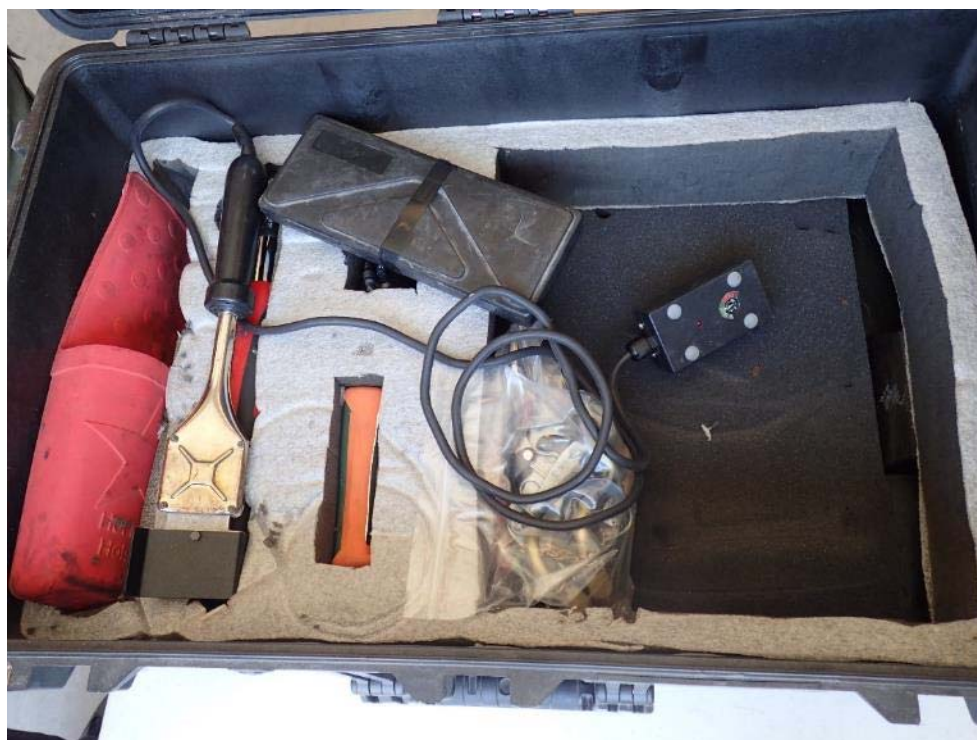
During the Invenergy site visit, a kit used to weld IBEX belts was provided for examination (Figures 5 and 6). When installed into a tower, the IBEX belts are formed into a loop by welding two ends together. The welding kit presented by Invenergy was described as a typical kit, but was not confirmed as the kit that was used to weld the subject IBEX belt.

Figure 5. Views of an IBEX belt welding kit owned by Invenergy. This kit was available for visual examination, but not confirmed as the welding kit used to install the belt involved in the fall incident.

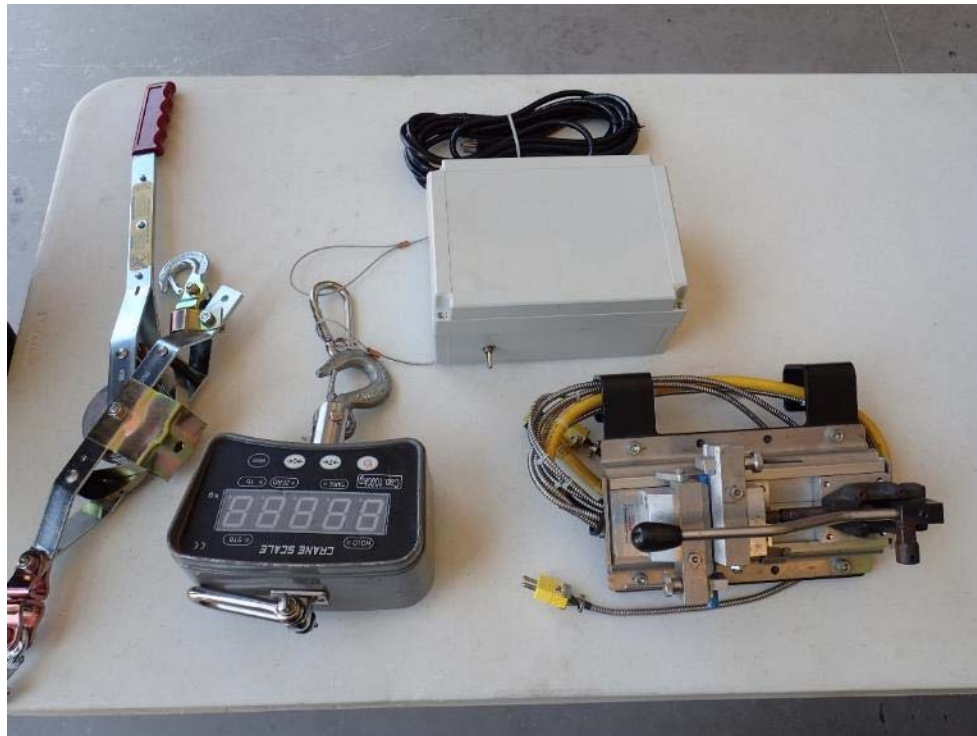
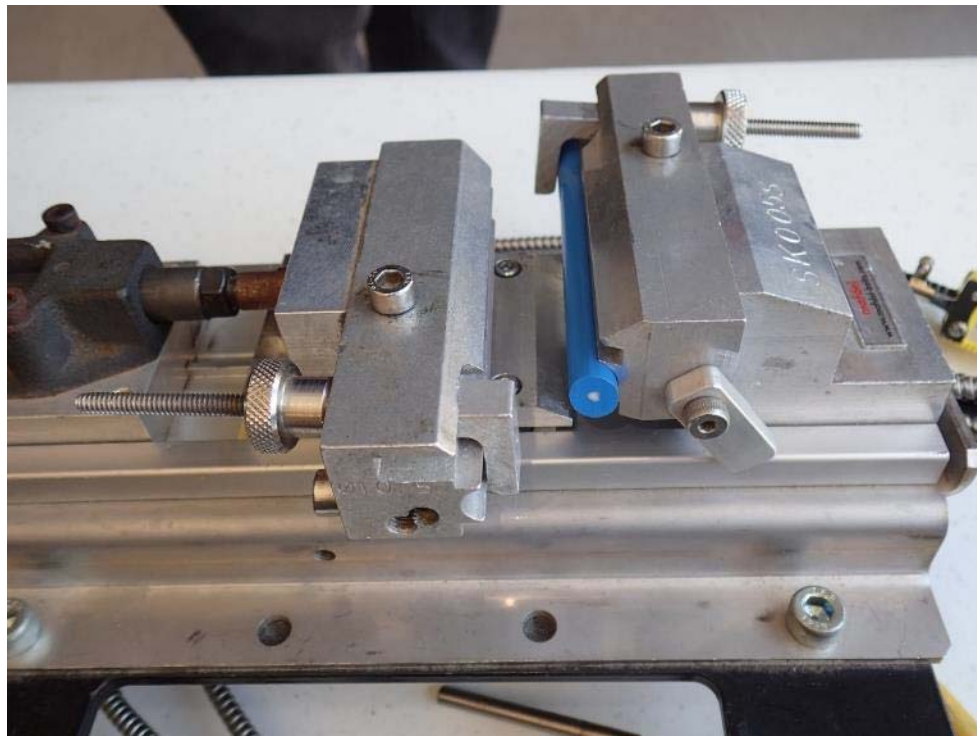
Figure 6. Additional views of components in the welding kit presented by Invenergy.

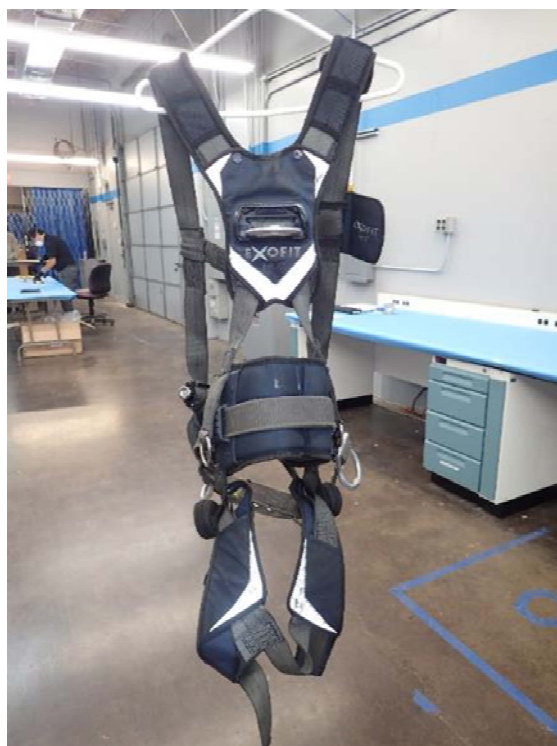
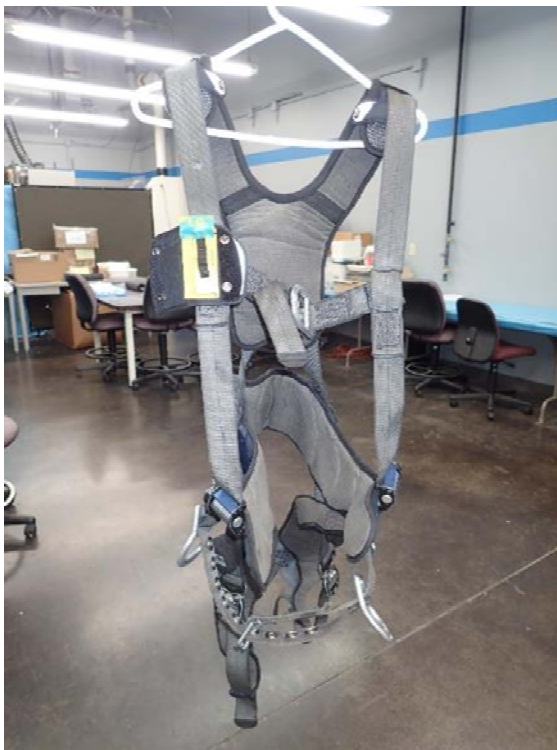
Various items associated with the fall incident were visually examined at the ESI Laboratory facility in Dallas, Texas, on August 19, 2020. These items included the harness that Mr. Moore was wearing (Figure 7). The harness was identified as a DBI (Sala) Exofit Model 1113192, Lot No. 2790214, and Serial No. E004035007A8A1A. The harness did not exhibit any obvious indications of damage or broken parts.

Figure 7. Views of the harness that Mr. Moore was reportedly wearing at the time of the fall incident.

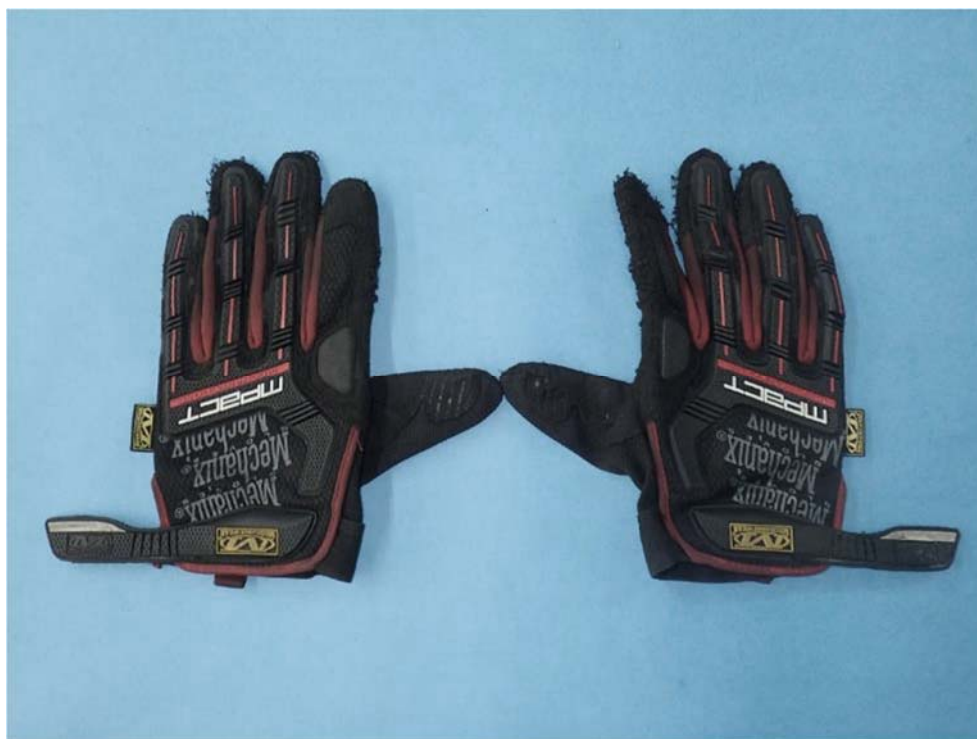
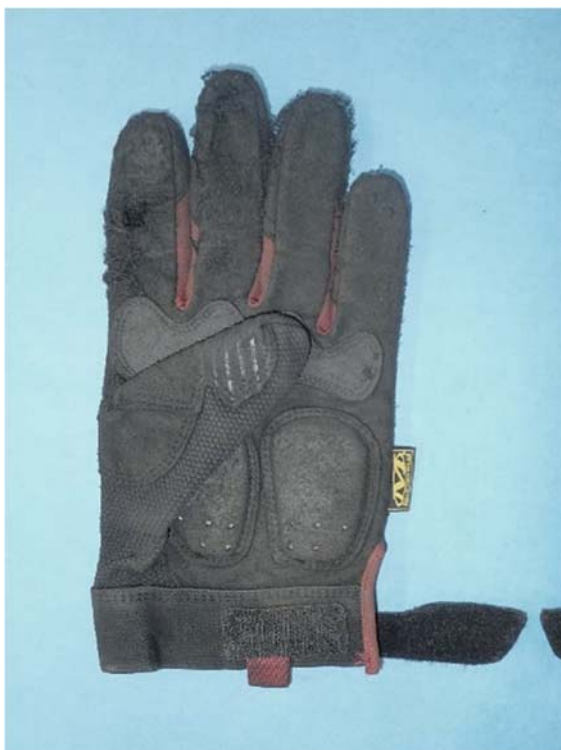
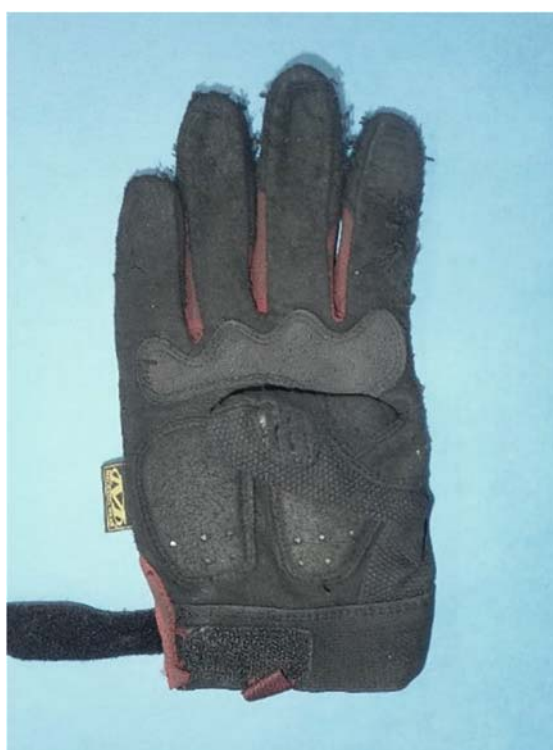
The gloves that Mr. Moore was wearing were also available for examination (Figure 8). The gloves were manufactured by Mechanix and indicated as the “MPACT” style. The gloves exhibited some degree of wear, but no evidence of tears or holes.

Figure 8. Views of the gloves that Mr. Moore was reportedly wearing at the time of the fall incident.

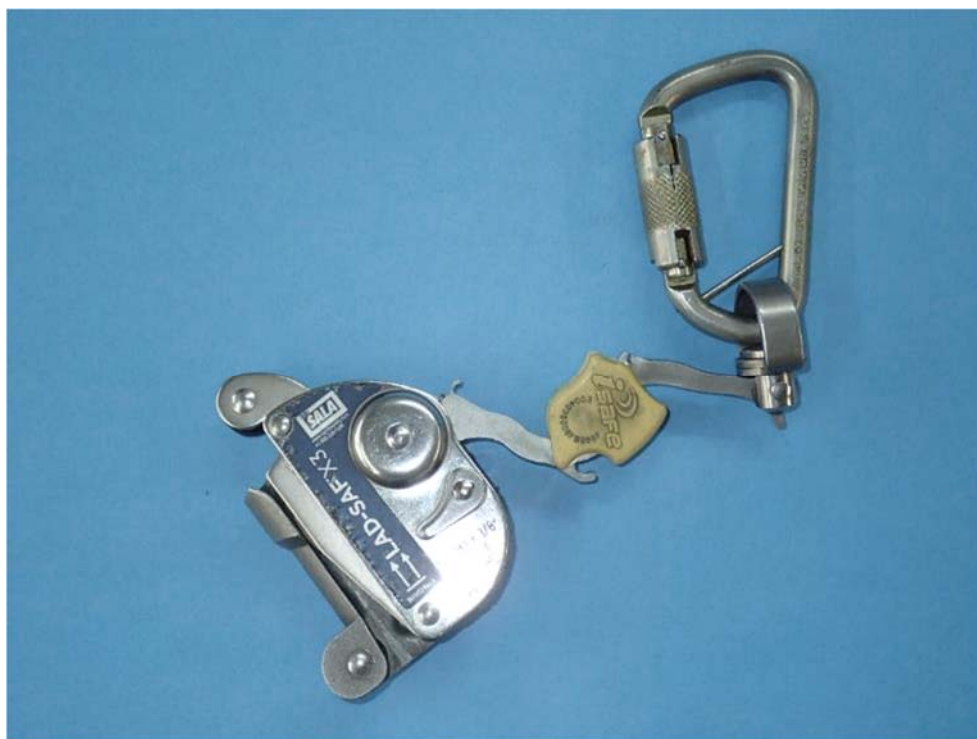
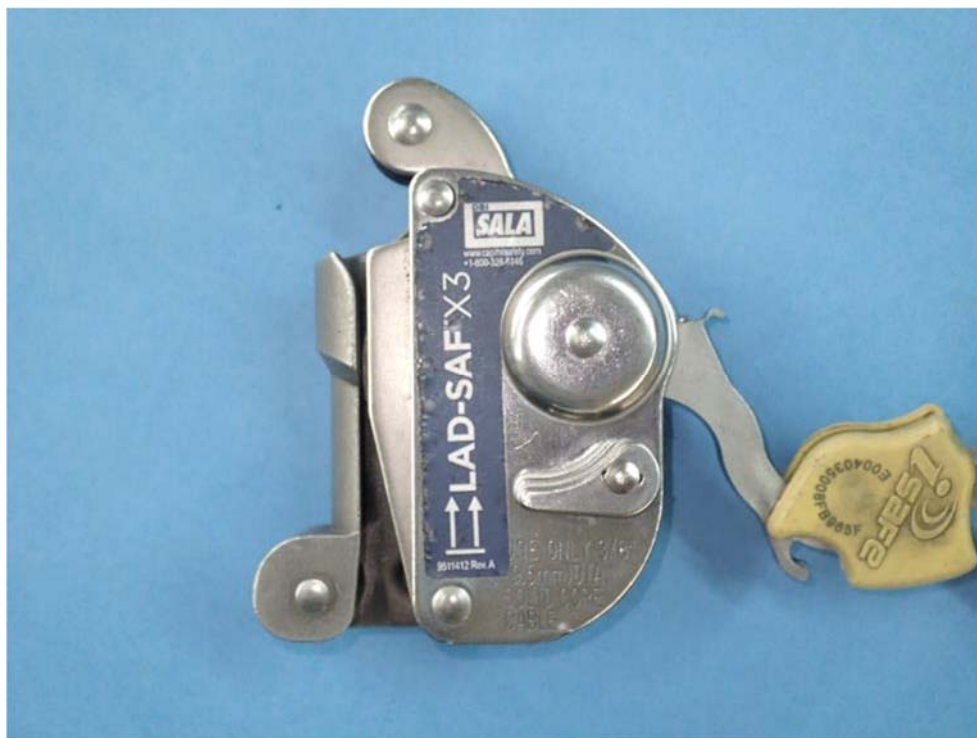
Mr. Moore's Lad-Saf X3 sleeve was available for visual examination at the ESI facility (Figures 13 and 14). Markings on the sleeve identified it as Model No. 6160054 with Serial No. 0005580. The sleeve included an attached carabiner, and the locking arm (energy absorber) was deployed (in a stretched condition). Aside from the deformed energy absorber, which was stretched to a length of approximately 5-3/8" (pin-to-pin) and slightly twisted, no other components exhibited evidence of deformation or cracking.

Figure 14. Additional views of the Lad-Saf X3 that Mr. Moore was reportedly using at the time of the fall incident.

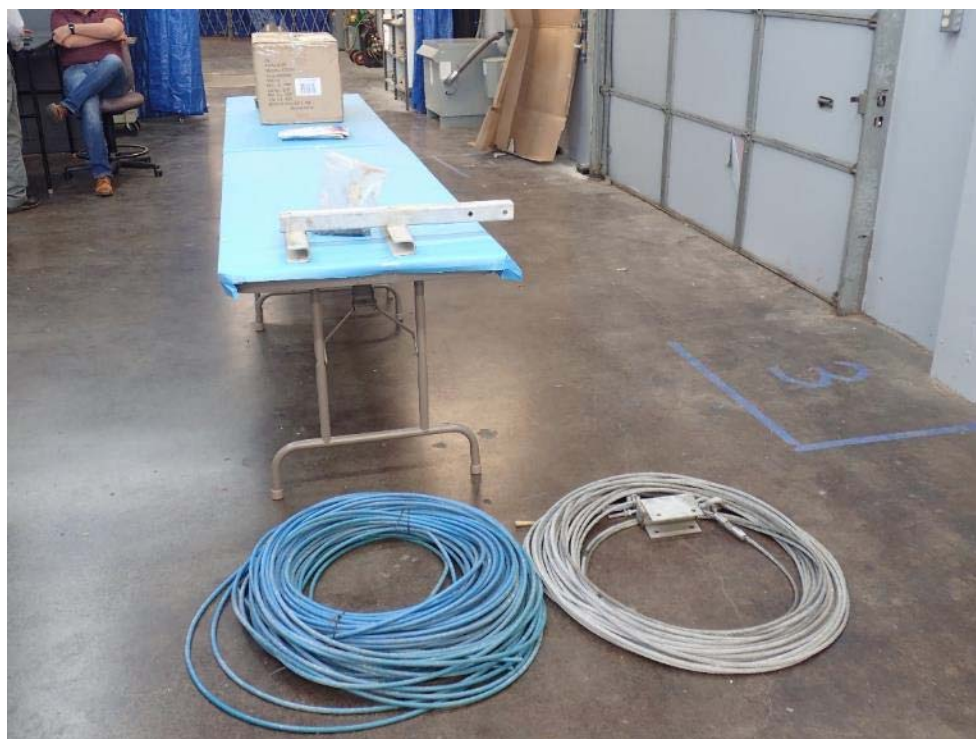
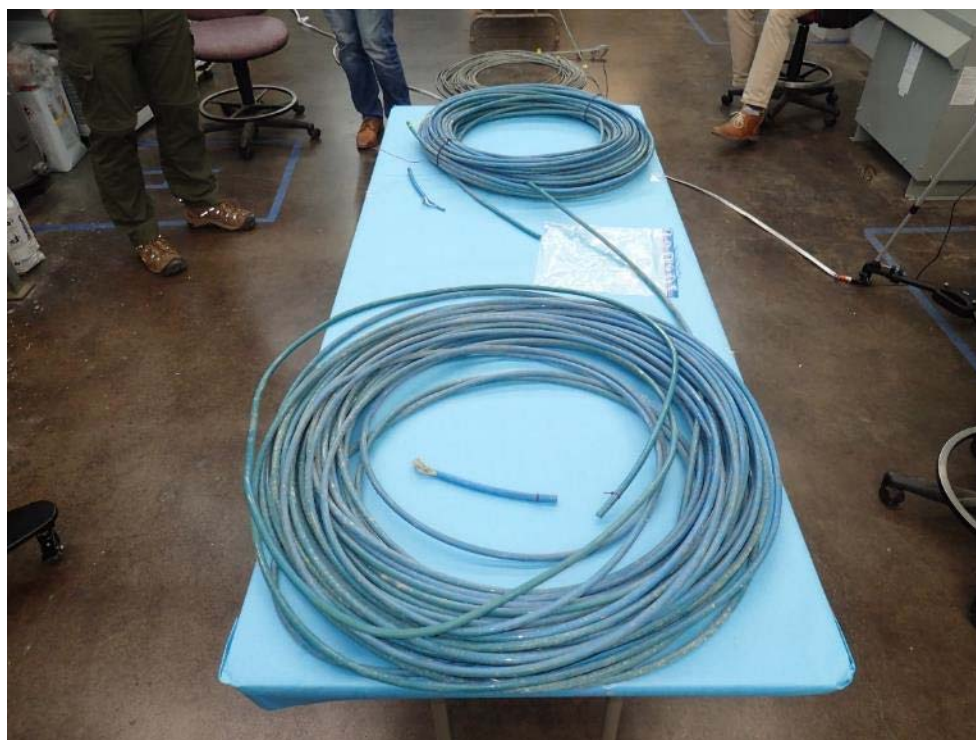
The IBEX belt segments and Tuf-Tug cable stored at the Invenenergy site were transported to the ESI Laboratory in Dallas, Texas (Figure 15). Although the IBEX belt would have been installed in the tower as a single loop (after welding the ends together), the belt was in multiple sections as a result of cuts that were made subsequent to the fall event (Figure 16). At least one of the cuts was identified as a match to a cut on the shorter failure segments. The belt was not uncoiled, but visual examination of the segments revealed at least two locations where deformation was evident (permanent bends) (Figure 17). The position of the weld at the time of the failure (relative to the Tower 41 ladder) was not determined.

Figure 15. Views of the IBEX climb assist belt (blue) and Tuf-Tug cable (metal) that were involved in Mr. Moore's fall incident, after transferring to the ESI laboratory facility in Dallas, Texas. The IBEX belt was in multiple pieces, including the smaller segments adjacent to the weld failure location.

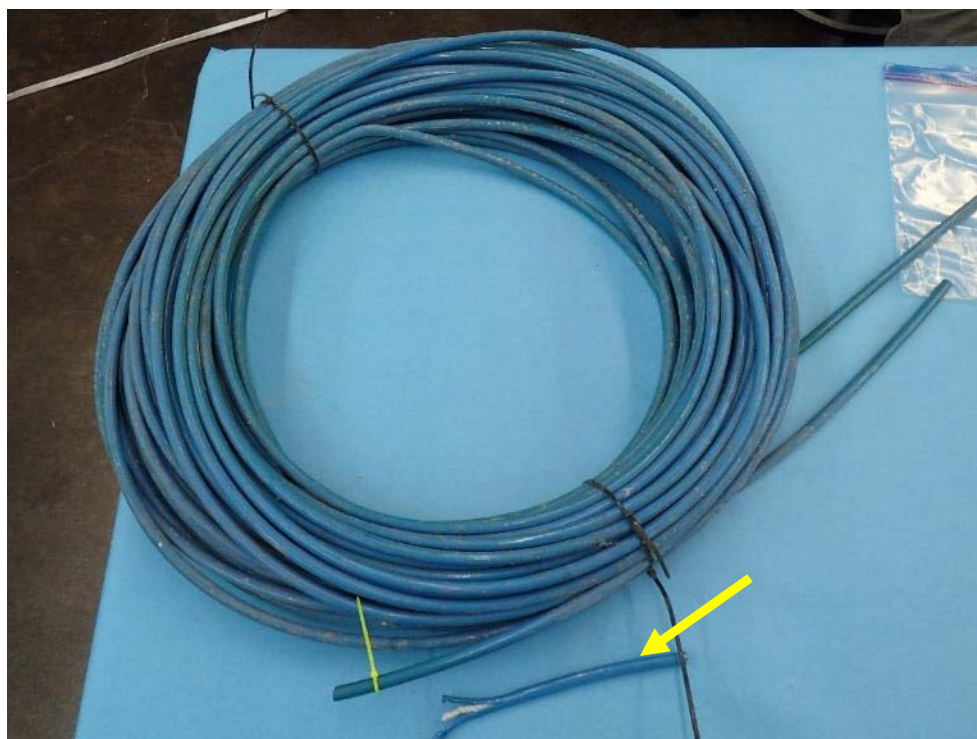
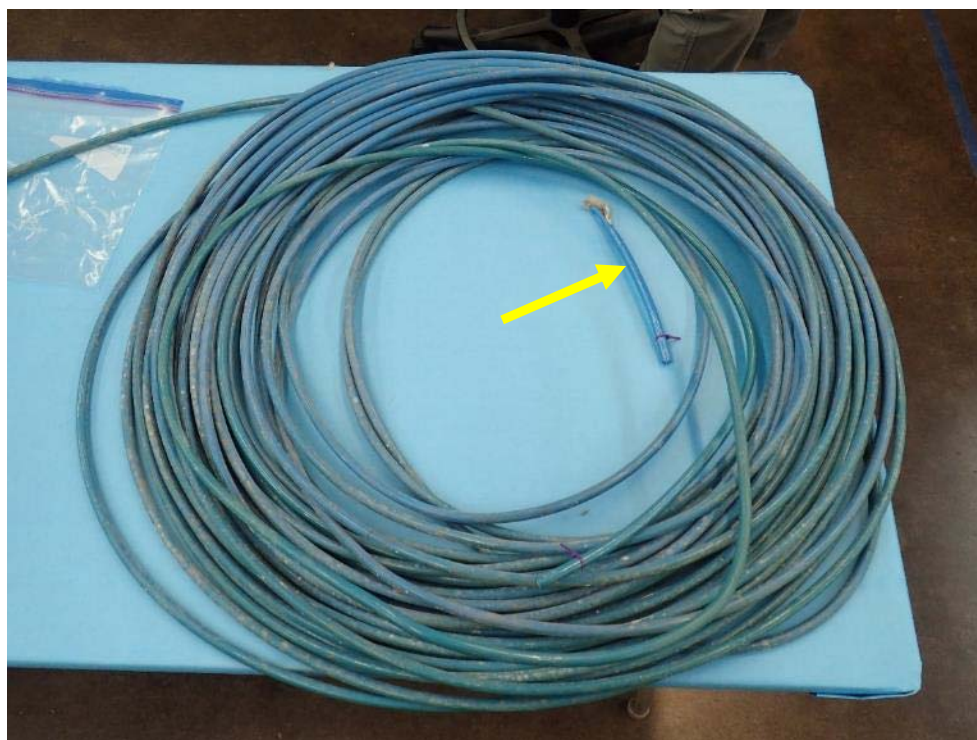
Figure 16. Additional views of the IBEX belt at the ESI facility. The two segments from the failure location are indicated by the arrows.

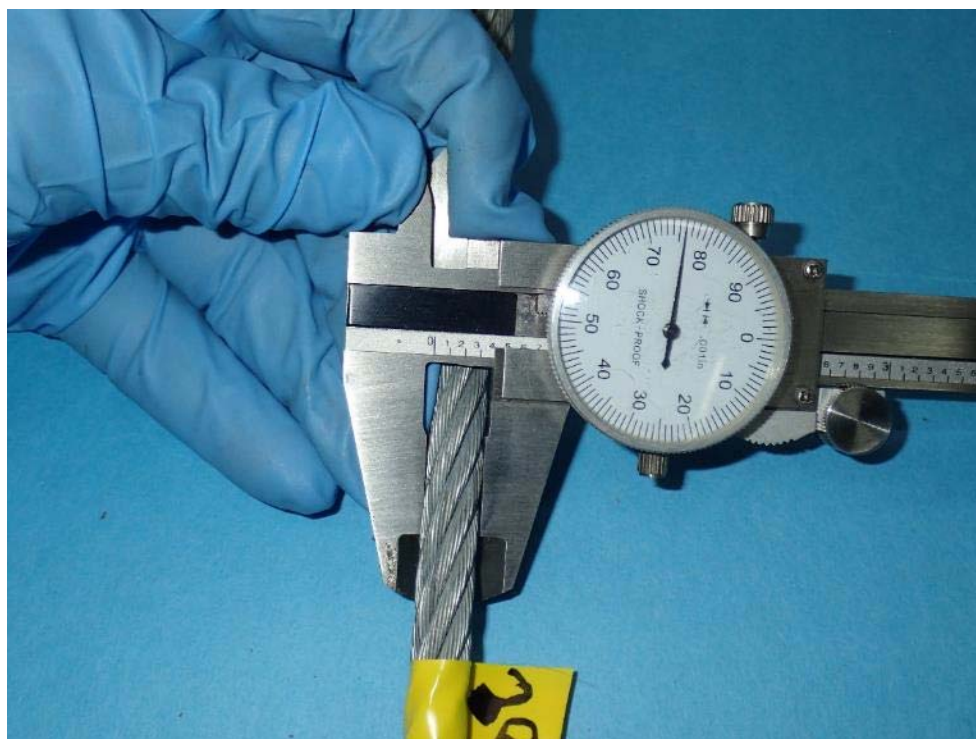
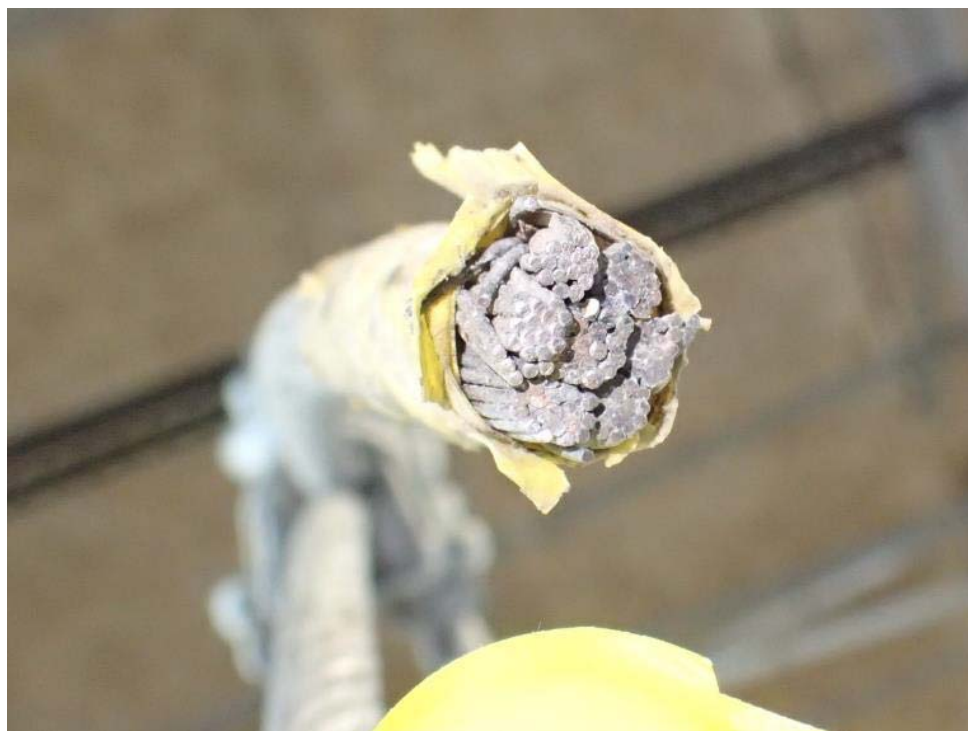
substance and deposits (dirt, debris) that was stuck to the surface. The diameter of the upper region of the cable was measured in multiple locations and at each location the measurement was consistent with 3/8" diameter cable (Figure 20). In addition, examination of one end of the cable revealed that it was 7x19 construction.

Figure 20. Views of a typical cable diameter measurement, which identified the cable as 3/8" diameter (upper image), and close view of the subject cable's 7x19 construction (lower image).

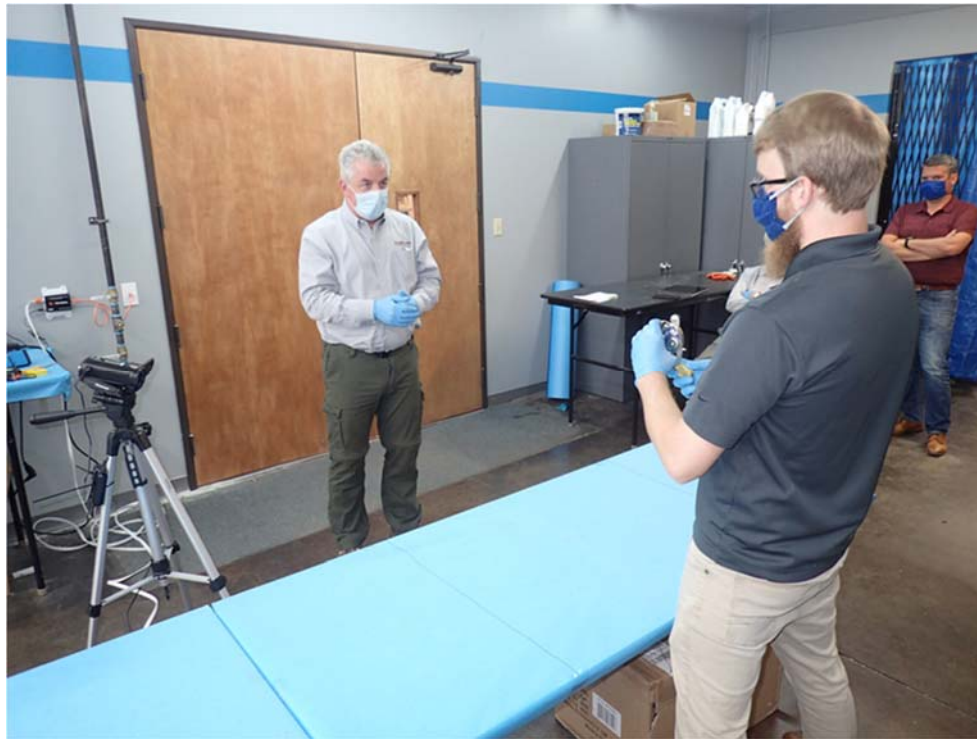
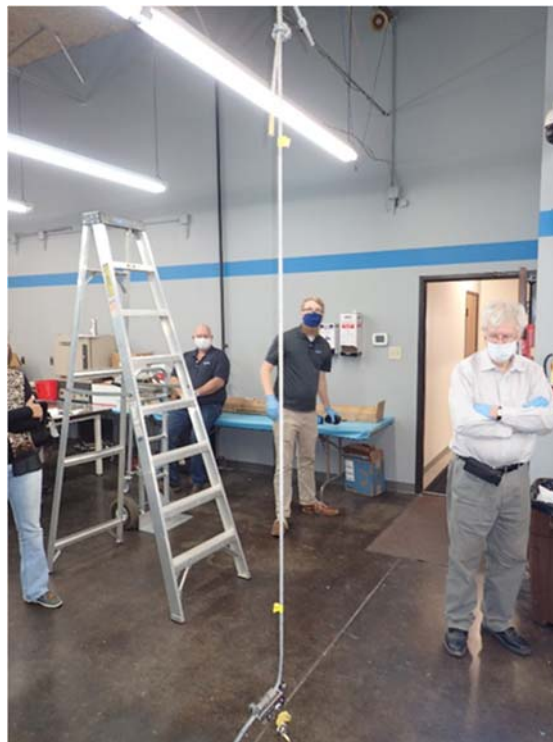
Figure 22. Views of an ESI technician performing manual tests on the subject Lad-Saf X3 sleeve (upper image) and the cable segment used to perform additional tests of the subject and exemplar sleeves (lower image). In the lower image, the lower end of the Tuf-Tug cable from the tower was attached to the ceiling and a weight was suspended from the cable to keep it tight during the testing.

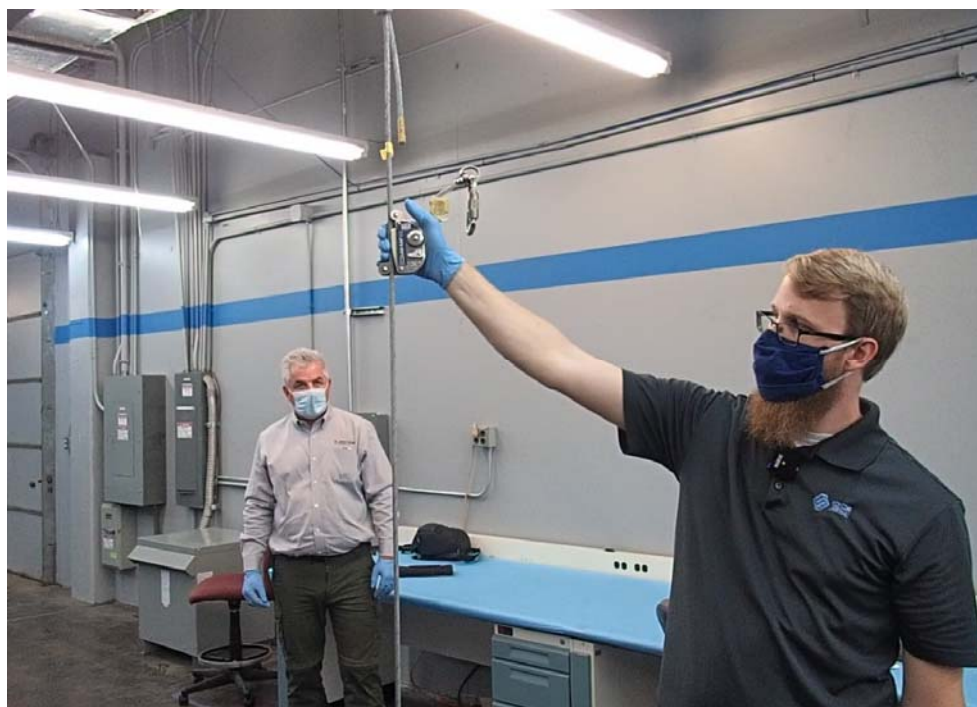
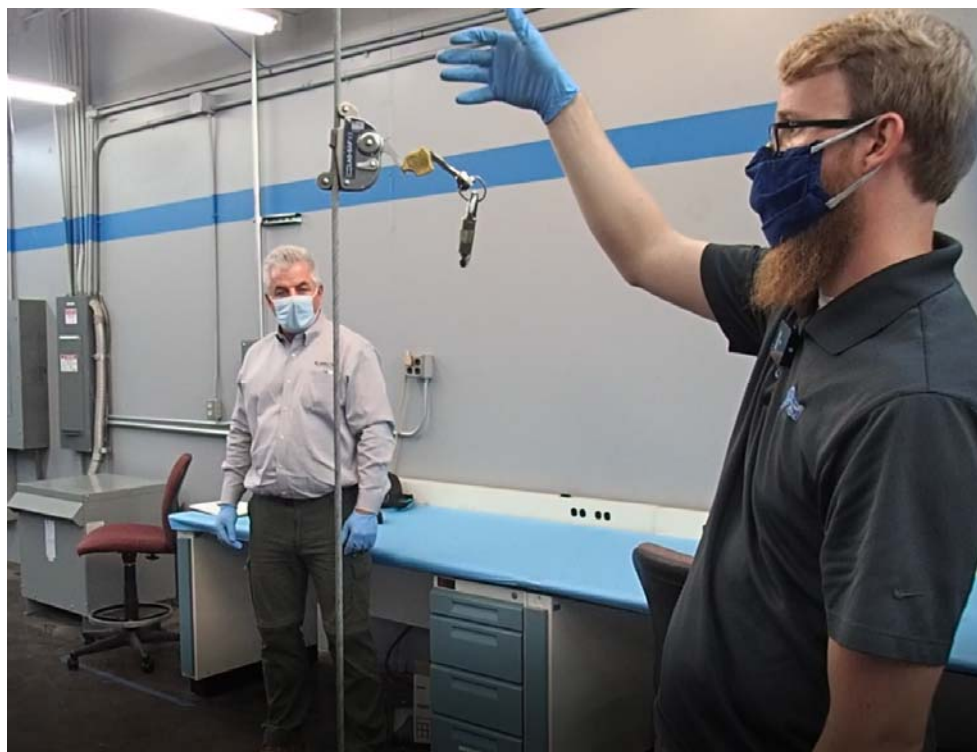
Figure 23. Views of the subject Lad-Saf X3 sleeve being tested on the temporary cable setup.

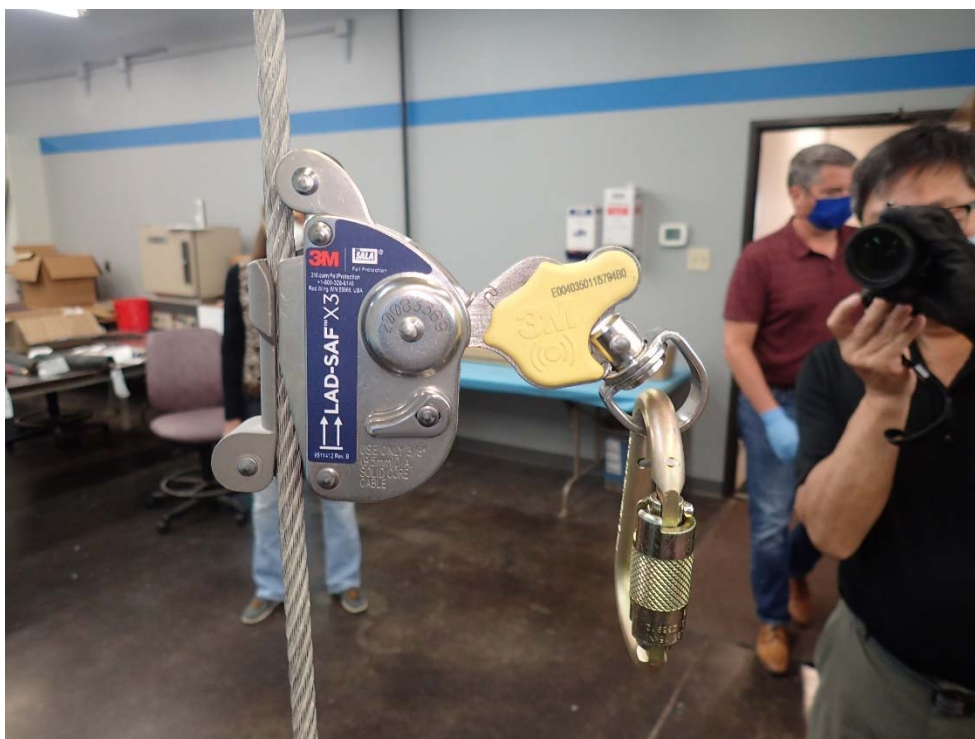
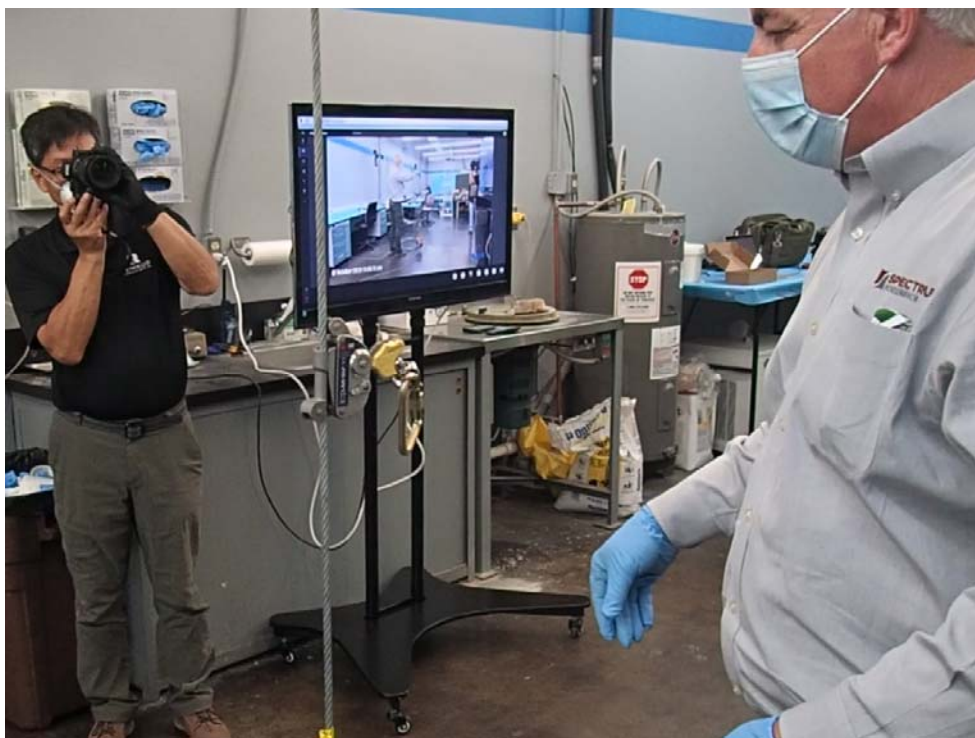
Figure 24. Views of an exemplar Lad-Saf X3 sleeve being tested on the temporary cable setup.

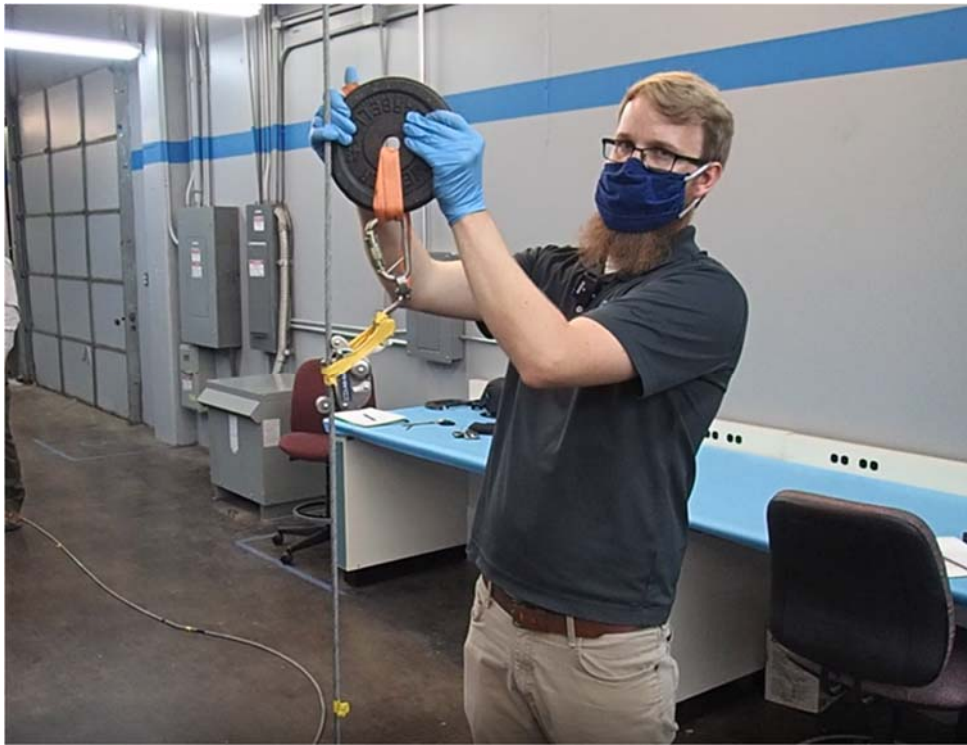
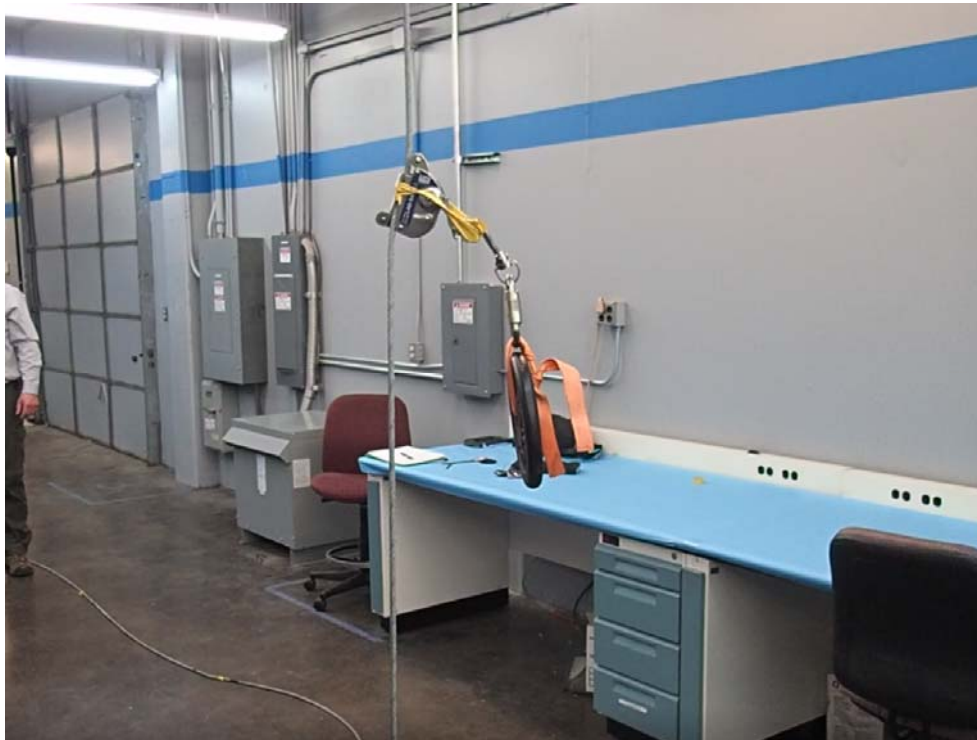
weight was raised up and then dropped, the sleeve engaged the cable such that the weight then loaded the locking arm, stretching the tape (Figure 25). Overall the testing performed on both sleeves resulted in expected behaviors for the sleeves.

Figure 25. Views of the subject Lad-Saf X3 sleeve during a dynamic test that was performed by taping the locking arm in the up position, attaching a 10 lb weight to the carabiner, and dropping the weight. When the weight was dropped, the sleeve locked onto the cable, causing the weight to pull the locking arm down and stretch the tape.
